## **North Attleborough MS4 Year 5 Annual Report Attachments**

## BMP RETROFIT SITE INVESTIGATIONS

# Water Quality Limited Waterbodies Requirements

*MS4 Permit Year 5*

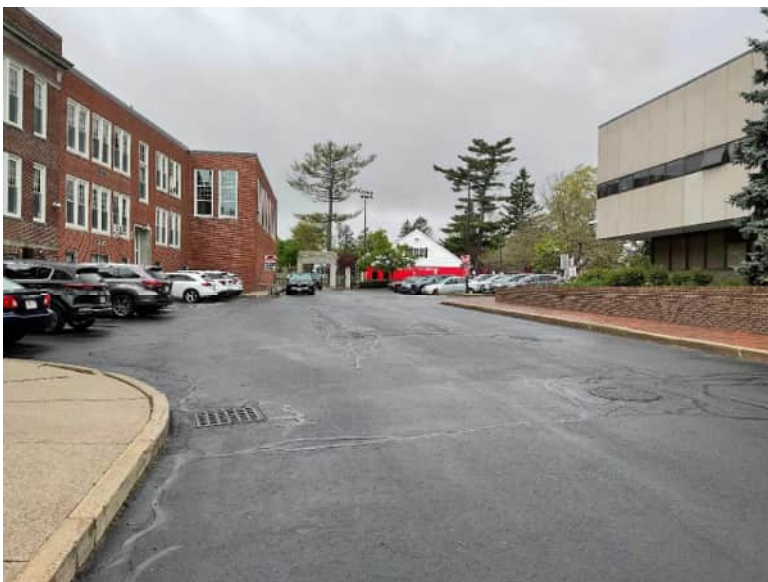
Partial catchment area for subsurface infiltration system.

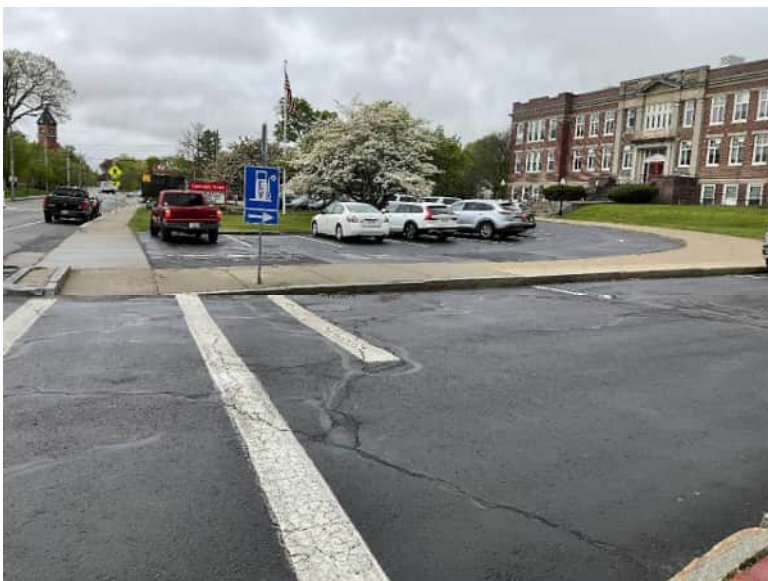
Potential location for subsurface infiltration system within open space in front of Community School building.

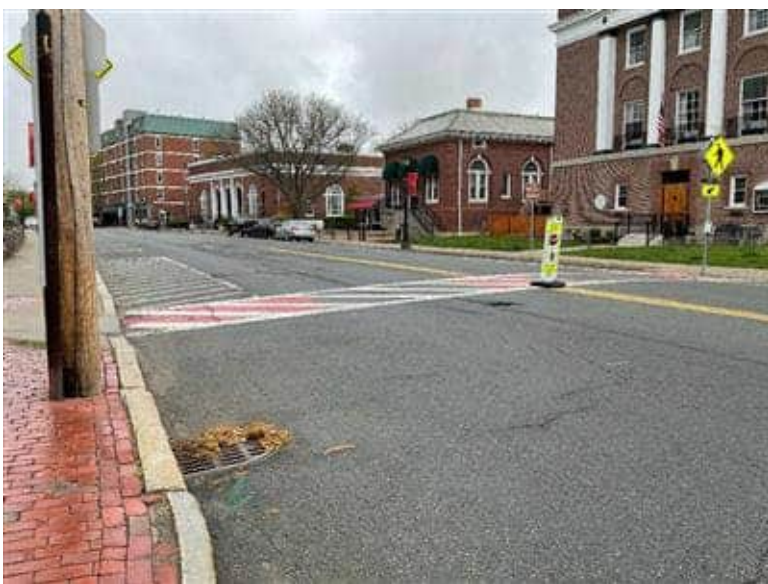
Section of S. Washington Street is included as part of the potential catchment area for the proposed subsurface infiltration system between Bank Street and Community School driveway entrance.

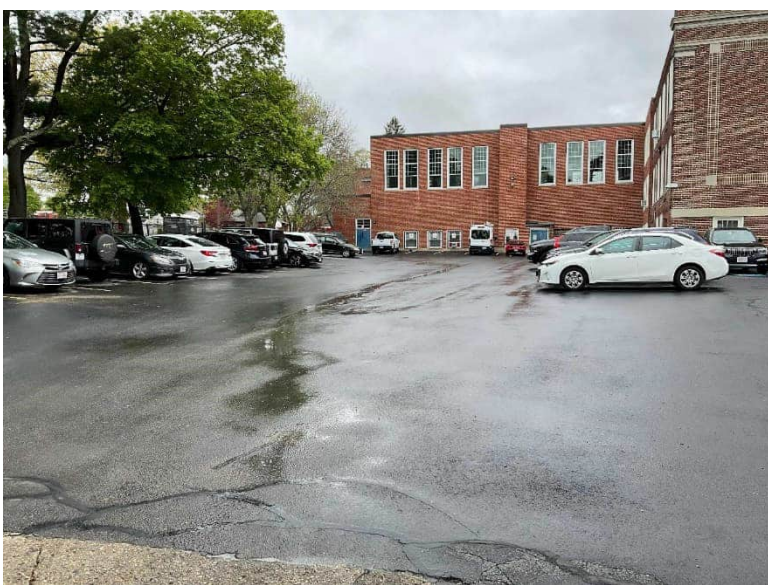
View of catchment with channelized flow visible to sidewalk. This flow exits the parking lot and outlets at a catch basin along Barrow Street.

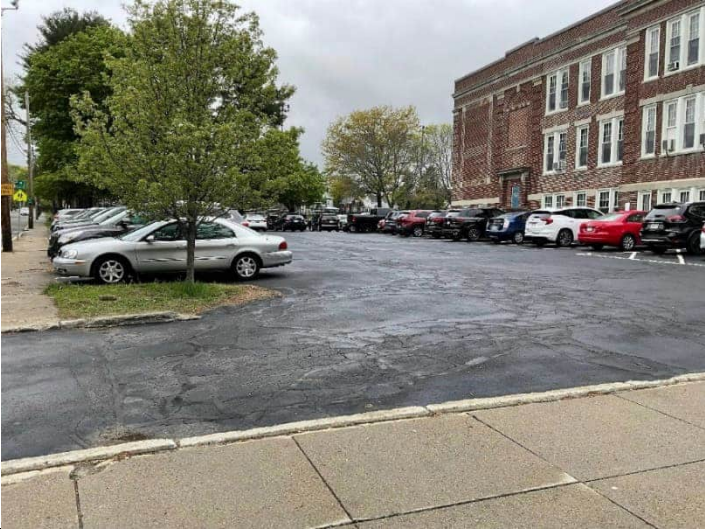
| | <p>View of parking lot catchment. This flow also exits the parking lot and outlets flows east along Barrow Street to the intersection with S. Washington Street</p> |

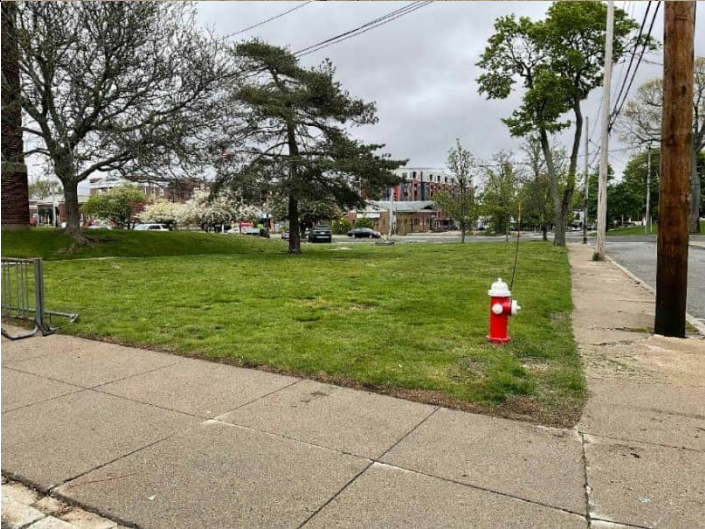
| | <p>Proposed location for surface infiltration Basin. Photo is taken facing east towards S. Washington St.</p> |

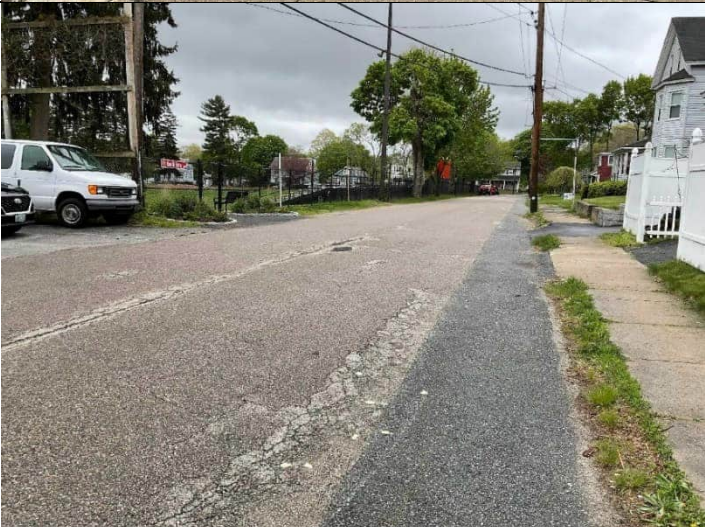
| | <p>Additional catchment for surface infiltration basin on Ralph Street. Photo taken facing south.</p> |

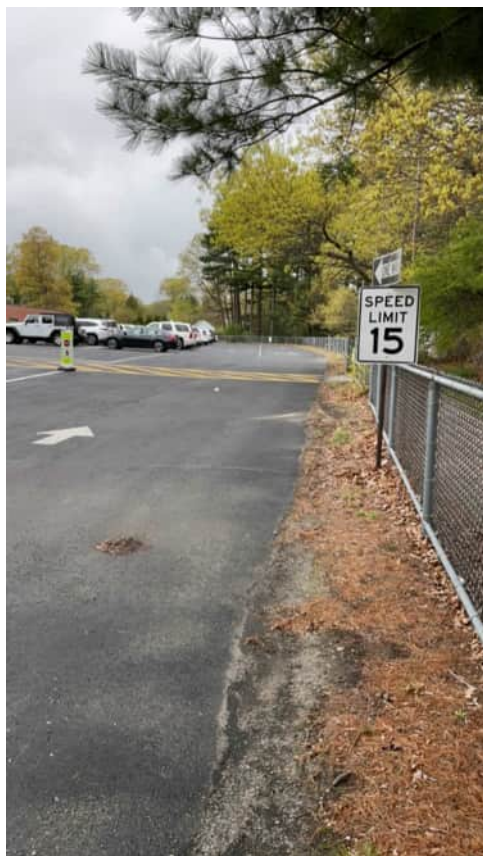
Opportunity for infiltration trench along east edge of property and parking lot. East parking lot is all pitched in this direction and infiltration trench could accommodate stormwater runoff from this area. Potential conflict with existing fence and water infrastructure.

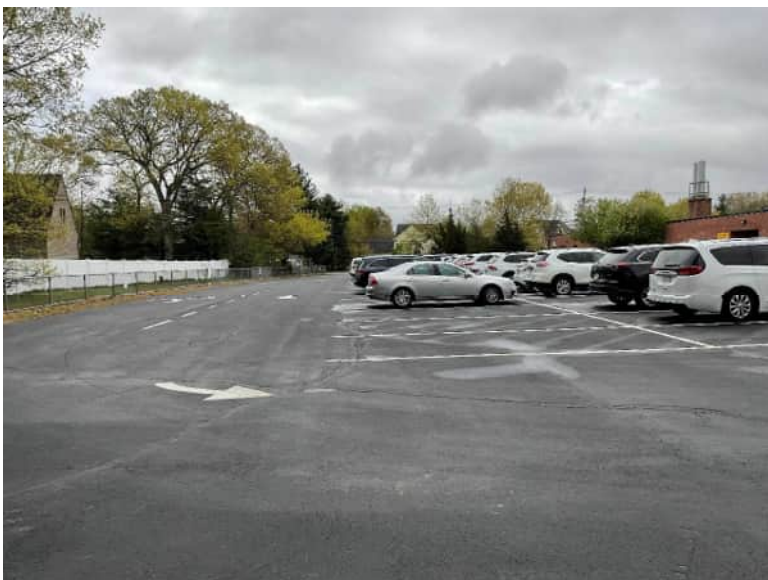
View of catchment for infiltration trench; photo taken facing south.

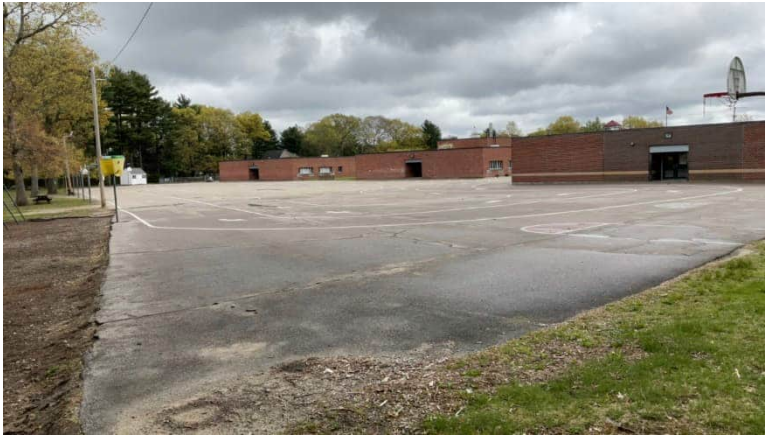
Large impervious area behind school is pitched towards single existing catch basin located in center. Opportunity to install series of leaching catch basins or manholes to infiltrate runoff from play area, or to divert existing catch basin outlet to a large surface infiltration basin.

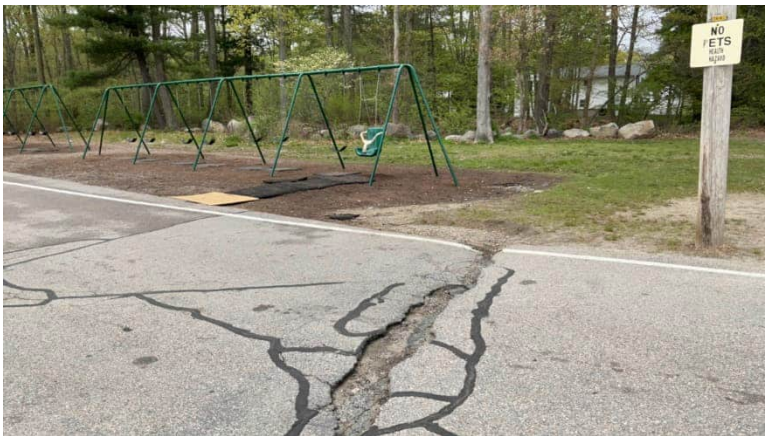
Distress in pavement has channelized; stormwater runoff flows to area near swings.

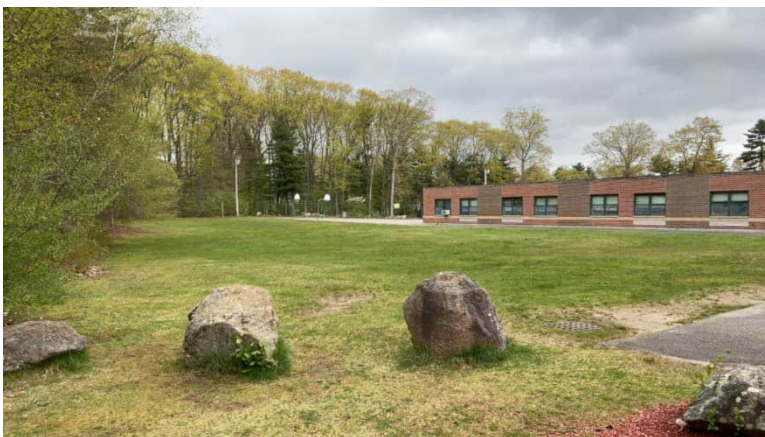
Opportunity to divert existing impervious play area and walkways behind school to large infiltration basin in unused grass area.

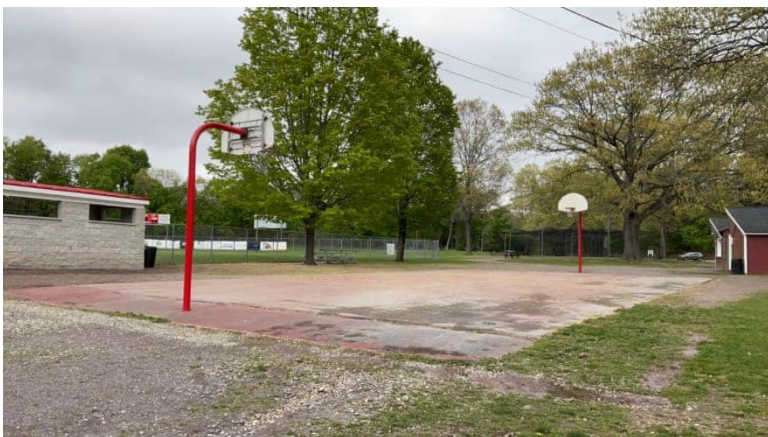
Town could install an infiltration trench along west and south edges of basketball courts with outlet to additional trenching along existing naturalized swale. Photo taken facing north east.

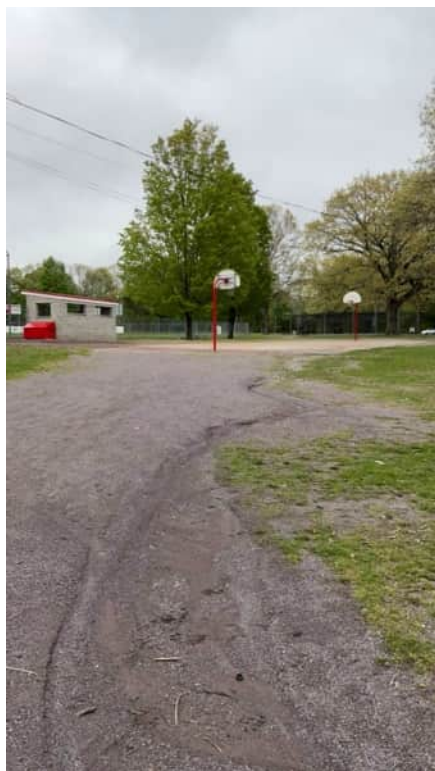
Opportunity for additional infiltration practice along existing informal channel photo taken facing northeast.

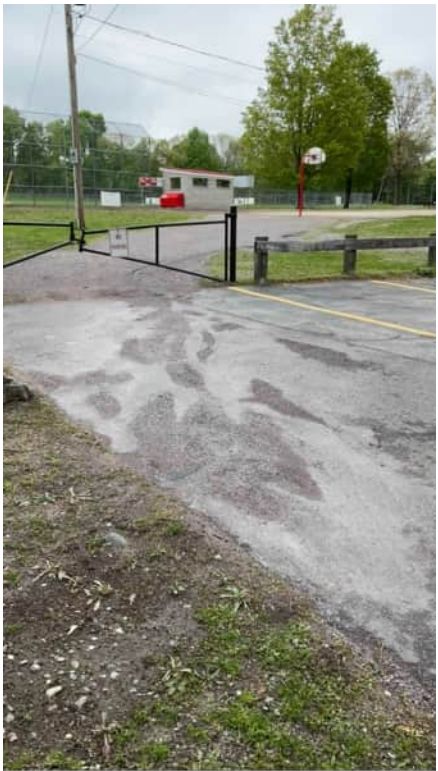
| | <p>Sediment washout from existing natural eye swell.</p> |

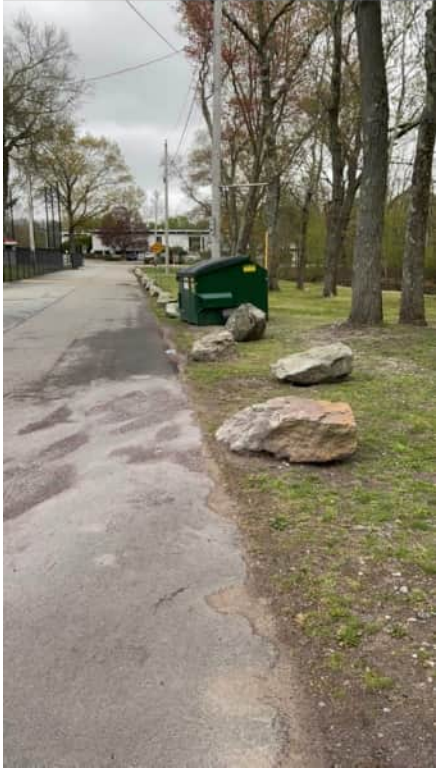
| | <p>Infiltration trench could continue along roadway edge to capture runoff before it reaches the tributary to the Ten Mile River. Existing boulders would need to move back but roadway is already pitched west.</p> |

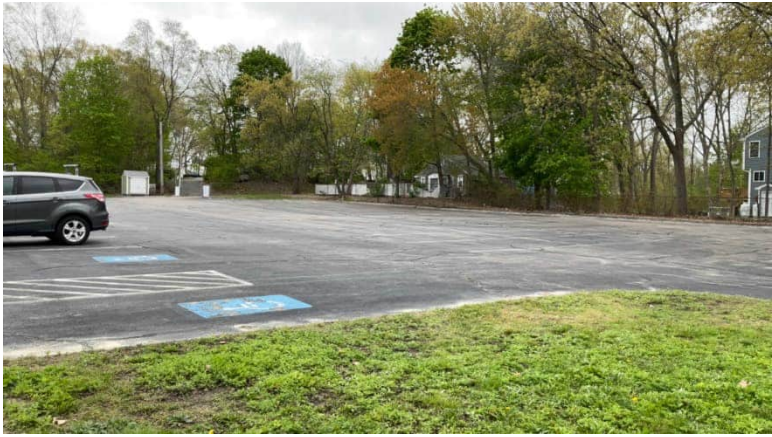
| | <p>Impervious catchment of existing catch basin.</p> |

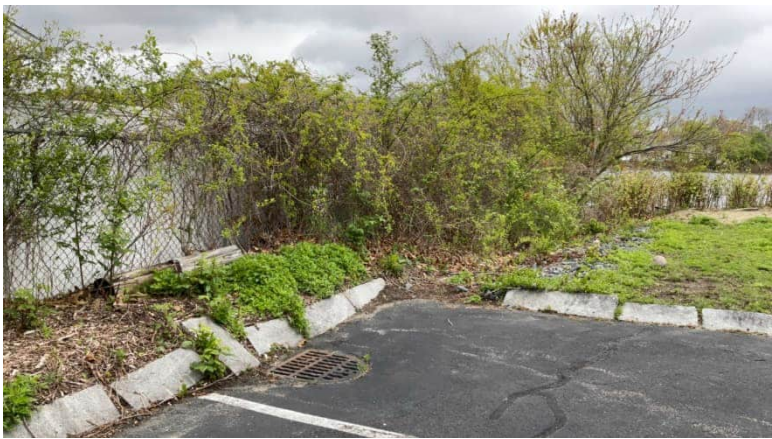
| | <p>Existing catch basin with curb cut to riprap lined overflow to lake. Existing outfall pipe from catch basin is currently submerged.</p> |

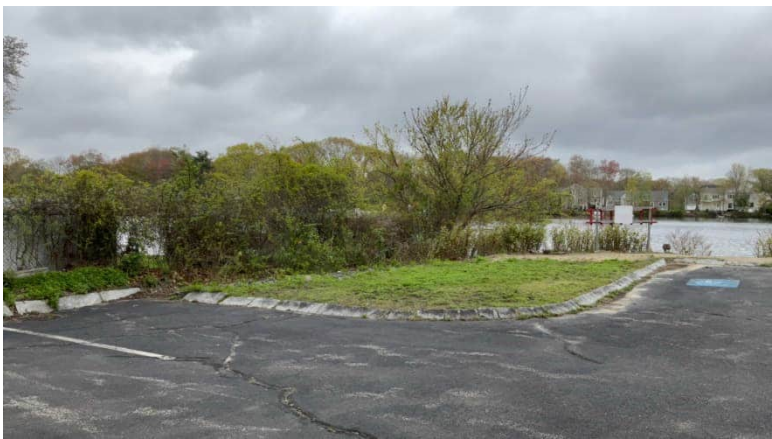
| | <p>Proposed location for subsurface infiltration system.</p> |

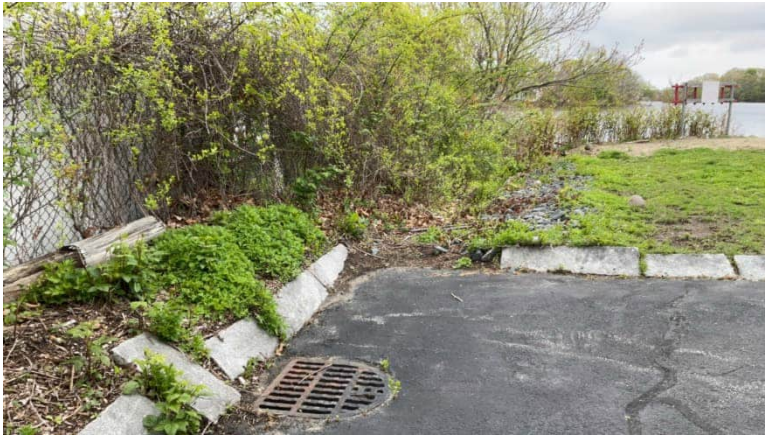
Existing riprap swale.

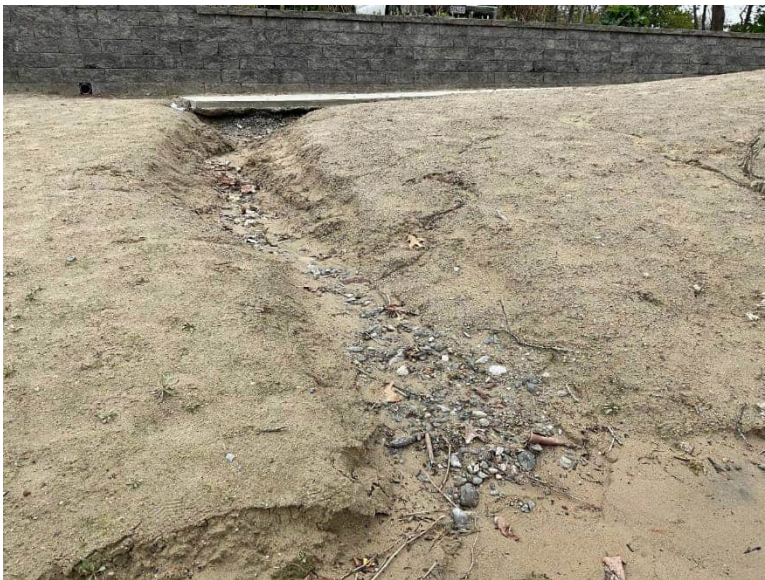
Significant erosion from sidewalk to bank is causing undercutting of concrete.

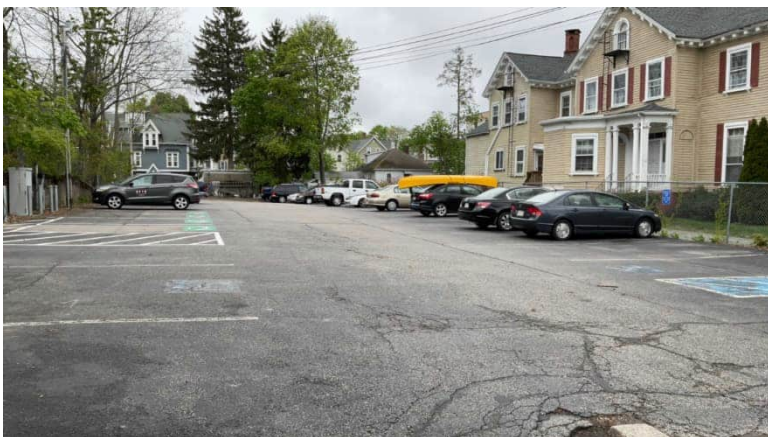
View of sight facing north from Church Street.

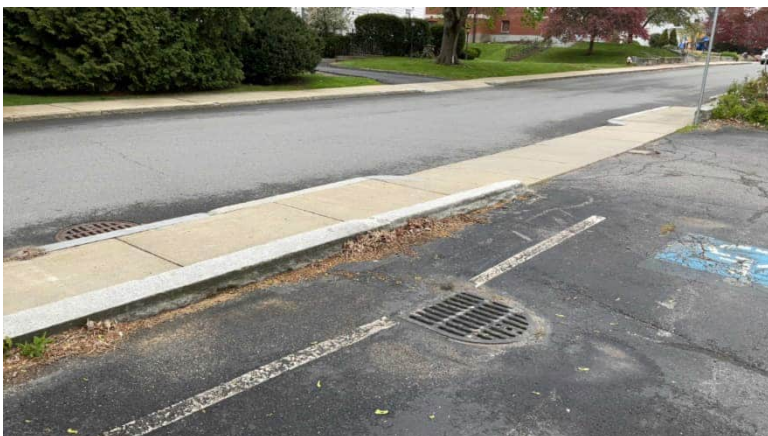
Existing catch basin at south end of parking lot outlets to stormwater infrastructure in the street.

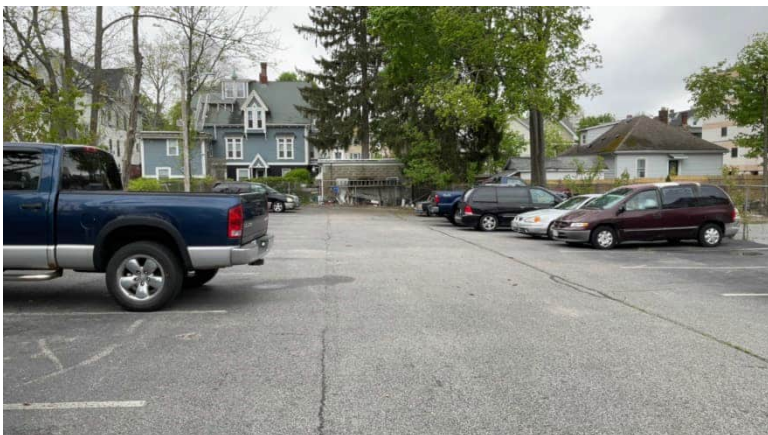
View of catchment for rear catch basin taken facing north.

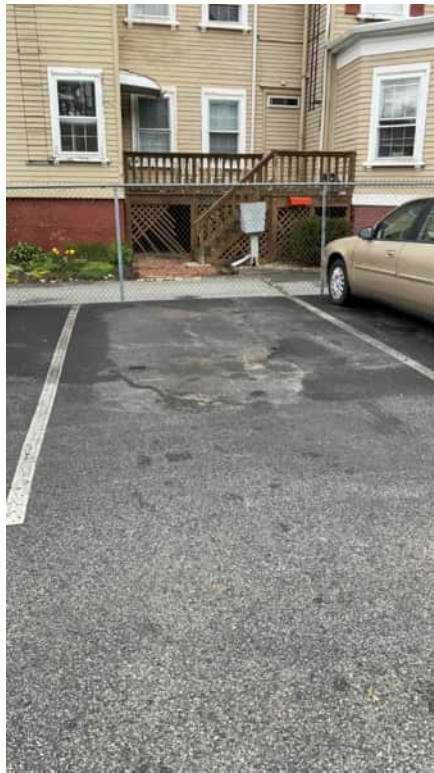
Oil staining from vehicles is  
apparent throughout lot.

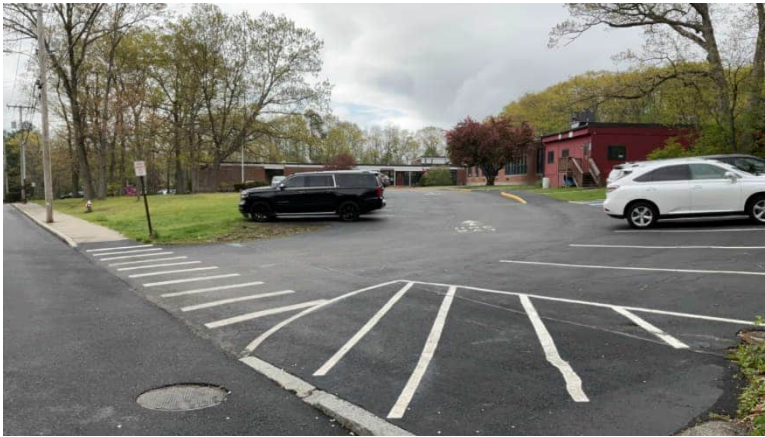
Large parking lot at Roosevelt Avenue School is pitched towards roadway and open space in front of school.

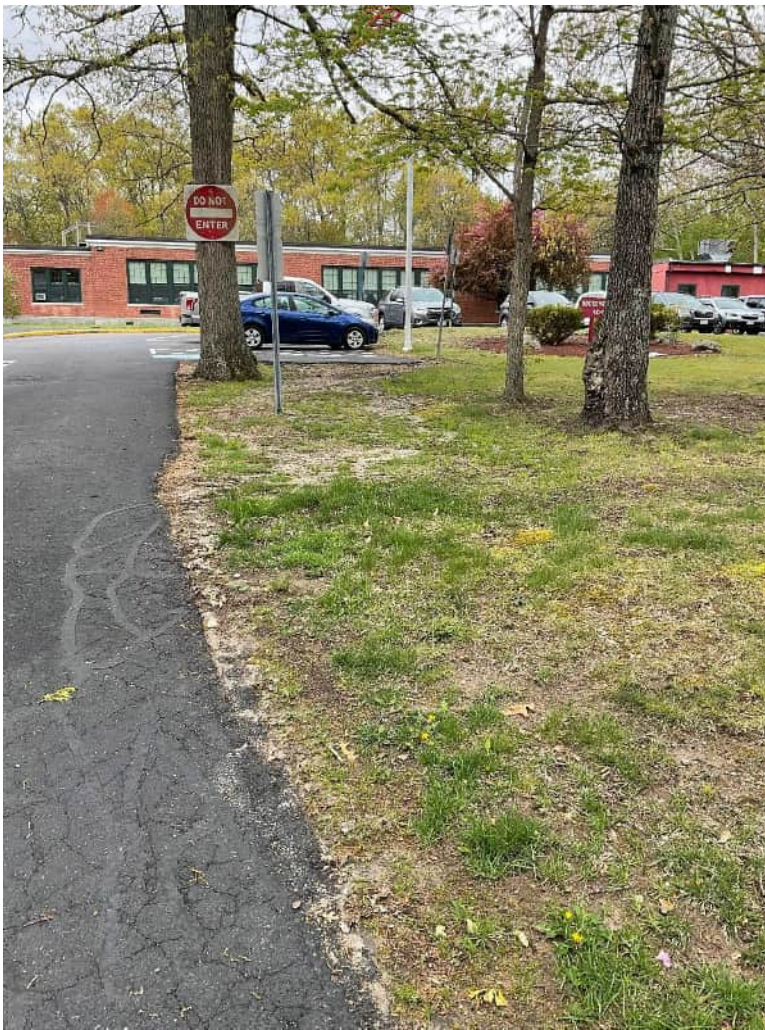
Channelized erosion coming off east driveway of front parking lot at Roosevelt School. Opportunity here to formalize with infiltration trench or swale depending on soil type.

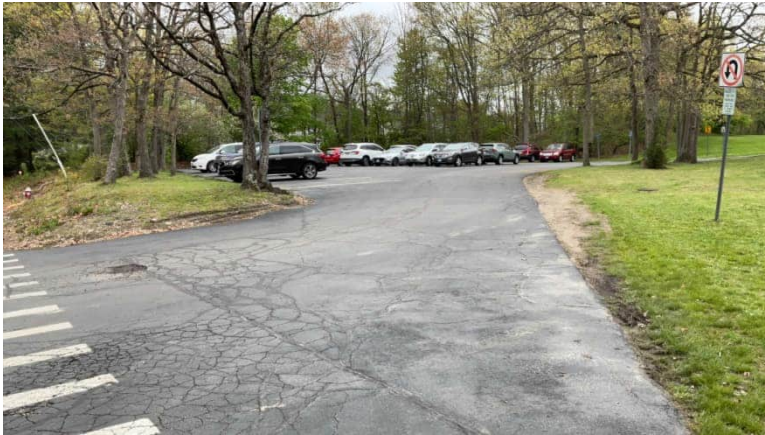
Rear parking lot at Roosevelt School. Photo taken facing southeast.

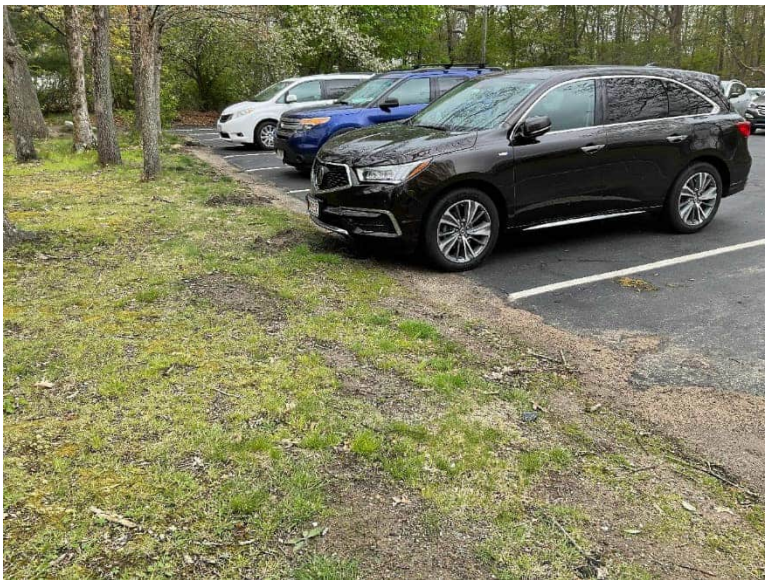
Opportunity to install infiltration trench to capture runoff along the northeast edge of the rear parking lot at Roosevelt School.

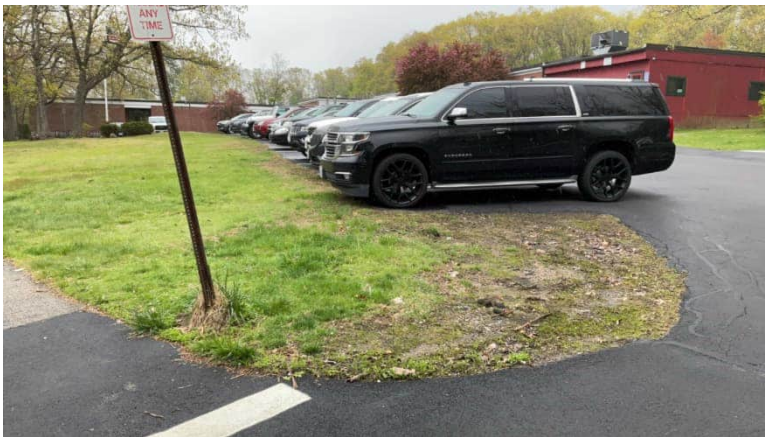
Opportunity to install bioretention planter at grassed corner where flow passes before reaching roadway. Additional opportunity exists to install infiltration trench along parking lot edge for additional treatment opportunity.

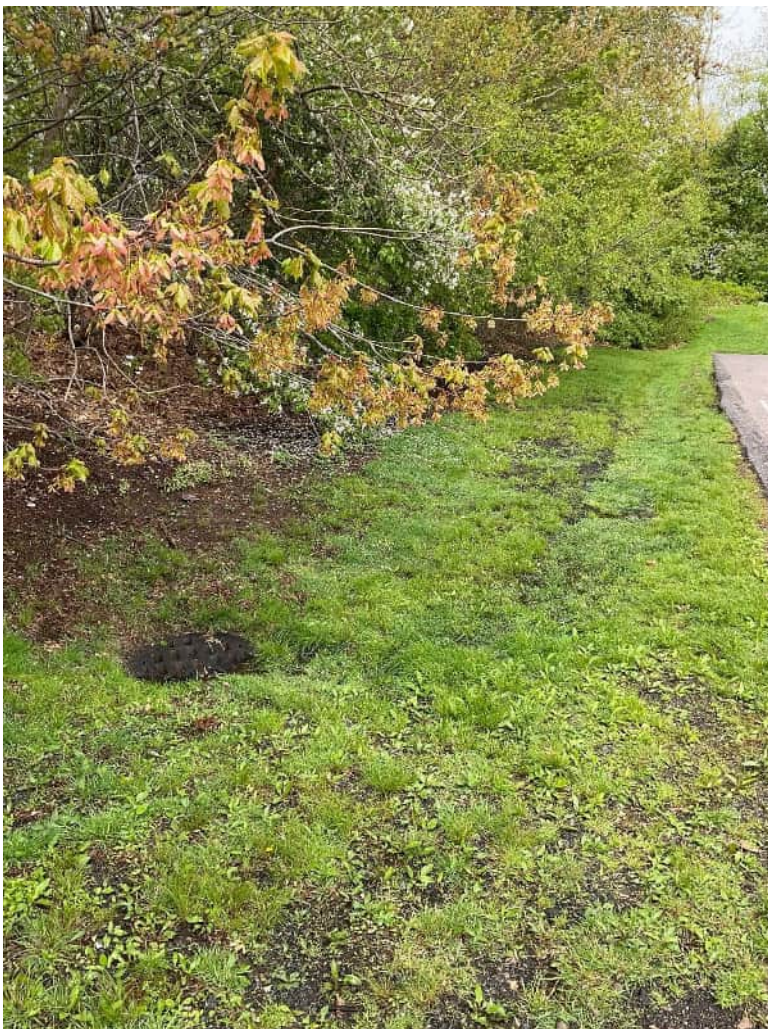
Yard drain in rear of building near large paved play area appears to have saturated soils in background after recent rainfall. This indicates relatively poor soils for infiltration.

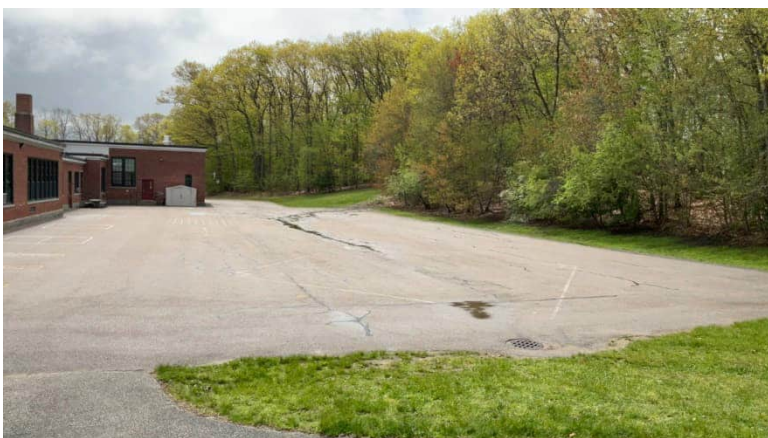
Large paved area in rear of school drains to catch basins with deep inverts.

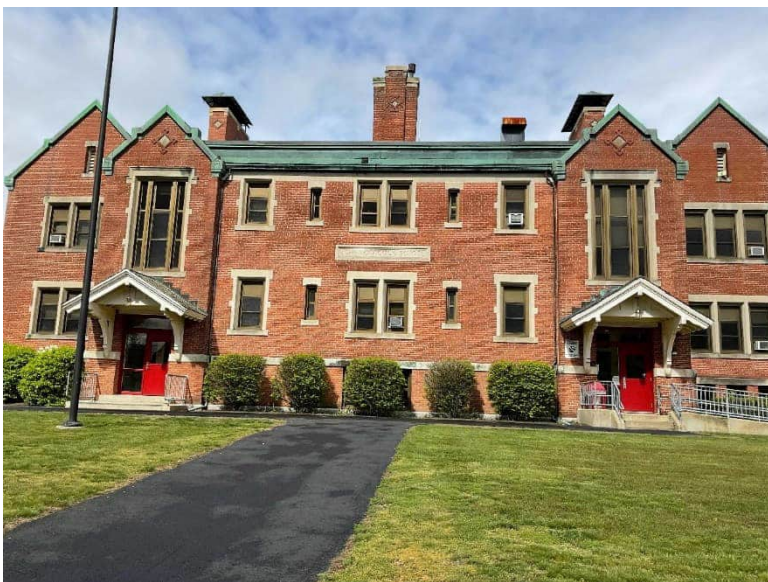
Roof leader is discharging to pavement in front of school along Morse Street; photo taken facing west.

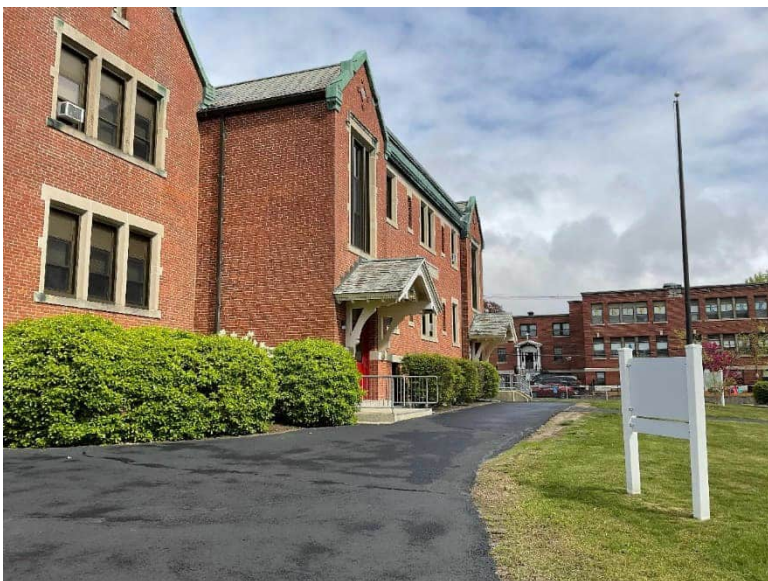
Potential location for infiltration trench along pavement edge that could except flow from front walk and portions of roof that discharge to surface; photo taken facing north

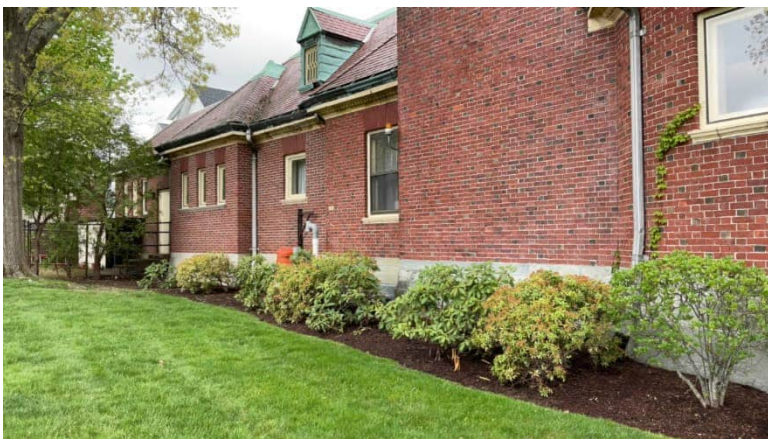
Roof leaders are buried and outlet at an unknown location. Opportunity to divert these to an infiltration or bioretention practice depending on soil type.

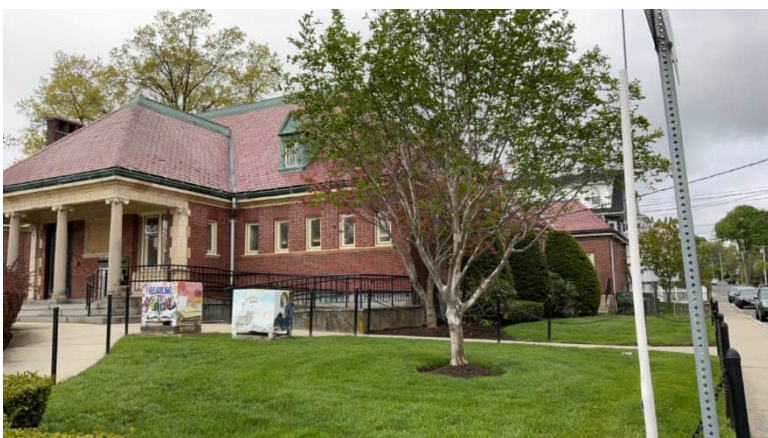
Grass areas present a potential location for bioretention or infiltration practice with roof leaders redirected to surface.

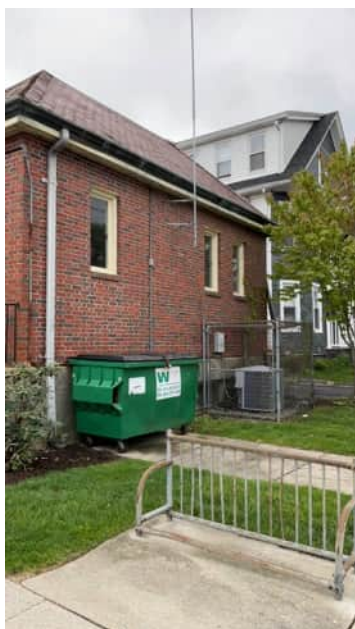
Leaders on north face of building discharge directly to impervious surface.
