Feasibility Study  
for the  
**Allen Avenue School**  
North Attleborough, MA

April 8, 2021

# 3-YEAR AHERA RE-INSPECTION REPORT AUGUST 2016

# **INDOOR AIR QUALITY PRE-OCCUPANCY ASSESSMENT**

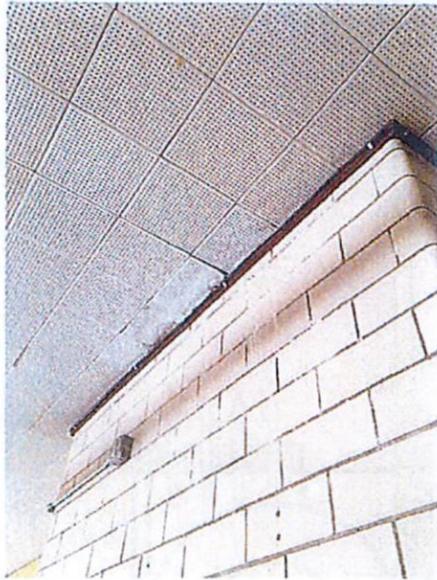
**Picture 1**

One room had water-damaged plaster around a fireplace/chimney (Picture 1), which likely indicates the flashing between the chimney and roofing material is damaged and needs repair.

**Water-damaged plaster around a fireplace/chimney**

1. Remove water-damaged carpeting in a manner consistent with US EPA "Mold Remediation in Schools and Commercial Buildings" (US EPA, 2008). This work should be performed when the building is unoccupied. In addition, due to the age of the building and the presence of asbestos-containing floor tiles, all work should be done in accordance with state and federal regulations.
2. Replace old, worn carpeting past its useful life (> 10-11 years). If not removed, clean carpeting annually or semi-annually in soiled high traffic areas as per the recommendations of the Institute of Inspection, Cleaning, and Restoration Certification (IICRC, 2012).
3. Seal all spaces inside of univents with a fire rated expandable foam.
4. Repair the junction between the chimney and roof to render watertight. Scrape and replace plaster.

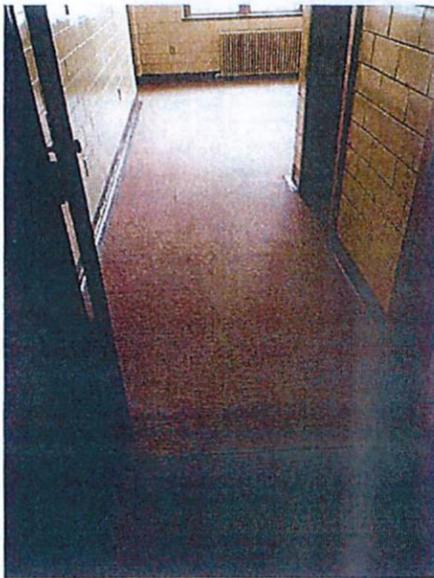
**Picture 2**

Of note is the use of wall-to-wall carpeting in some areas (Picture 2). The IAQ Program does not recommend the use of wall-to-wall carpeting in public buildings in general, due to the difficulty in maintaining in good condition, including wear, dirt and spills. Carpeting is also not recommended on slab foundations since it is likely that the materials will be exposed to moisture from condensation forming on floors in contact with the ground during humid weather and/or ground or storm water infiltration. Carpeting moistened periodically will be subject to microbial growth. The service life of carpeting in schools is approximately 10-11 years (IICRC, 2002). Aging carpet can produce fibers that can be irritating to the respiratory system. In addition, tears or lifting carpet can create tripping hazards. Carpeting should be cleaned annually or semi-annually in soiled high traffic areas as per the recommendations of the Institute of Inspection, Cleaning, and Restoration Certification (IICRC, 2012).

**Wall-to-wall carpet over tile**

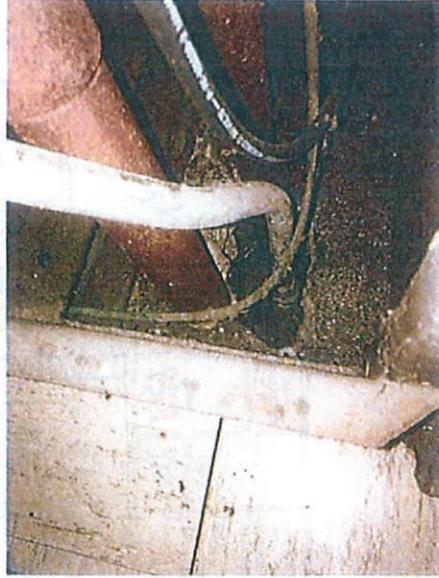
Picture 3

The interior of univents were examined. It appears that the school has a crawl space. Spaces were noted between the heating pipes and the floor (Picture 3). These spaces can allow for crawl space odors, mold and moisture to enter the interior of the building.

Space between floor and heating pipes inside univent
