# ROAD SAFETY AUDIT

South Washington Street (U.S. Route 1) at Draper Avenue,  
South Washington Street (U.S. Route 1) at Allen Avenue,  
&  
South Washington Street (U.S. Route 1) at North Attleboro  
Market Place Access Road

Town of North Attleborough  
September 5, 2017

Toole Design Group  
2 Oliver Street, Suite 305  
Boston, MA 02109

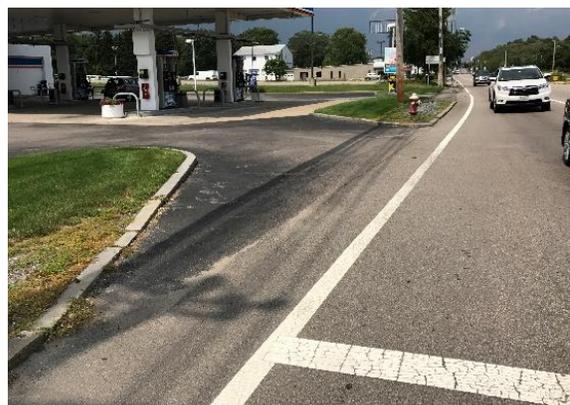
Audit team members noted that the presence of two gas stations and their associated curb cuts near the intersection meant that there were many conflicting movements immediately before and after the intersection. It was observed that motorists entering and exiting the gas station driveways on Draper Avenue often get stuck in queued traffic and block travel lanes while trying to use the driveways. These issues could be contributing factors to rear-end and angle crashes, such as was noted in crash 12 on the crash diagram.

**Figure 5 - Gas station driveway immediately adjacent to the intersection on South Washington Street**

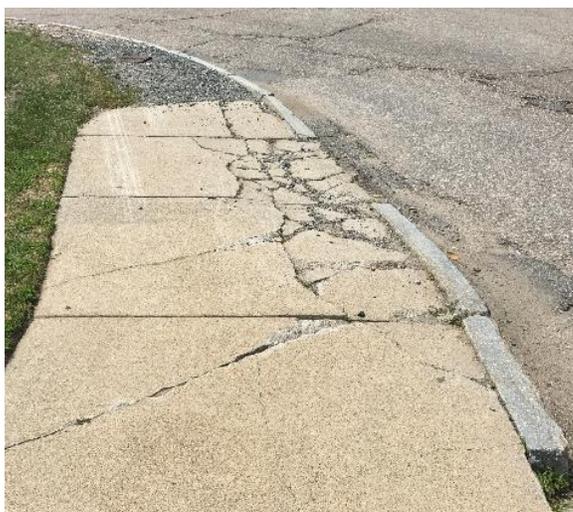
**Figure 6 - Damaged curb ramps and markings on sidewalk from vehicle encroachment**

Avenue. The encroachment would present a danger to pedestrians on the sidewalk, and damage to the curb ramp was clearly visible.

insufficient to accommodate the truck traffic turning from northbound South Washington Street onto Draper Avenue eastbound. This could cause conflict between northbound, right-turning trucks and westbound queued traffic, as trucks may need to swing into the westbound travel lane in order to complete their right-turns. This also could lead to vehicle encroachment on the sidewalk and pedestrian curb ramp along the south side of Draper

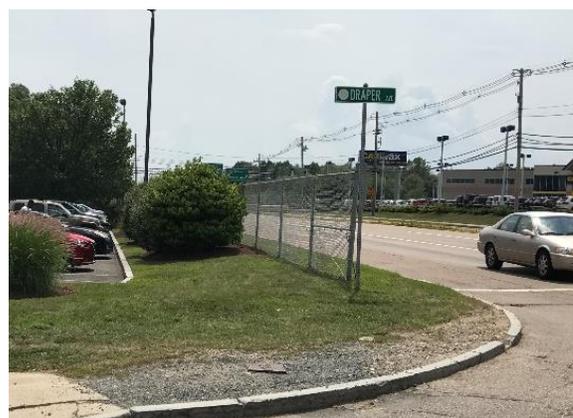
Audit team members observed that westbound motorists view to the south was obstructed by hedges and a fence on the Applebee's lot. Since right-turns on red are permitted off of Draper Avenue, this blocked motorist's view of the northbound traffic they are merging with.

**Figure 7 - Blocked view to the south from eastbound Draper Avenue**

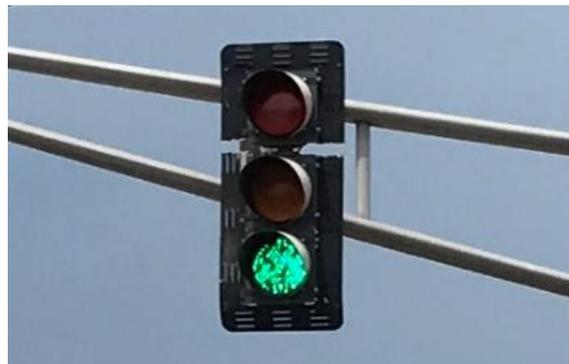
Several audit team members observed that some of the traffic lights were not updated to the latest LED style lamps. It was noted that previously there had been a program to update all traffic signals along the corridor to LED style bulbs, but many of the yellow lights and some auxiliary lights were not updated as a cost-saving measure. As such, intersections along the corridor often have a combination of LED and incandescent bulbs in the traffic signals. It was also noted that some of the LED bulbs that had been installed were partially darkened and/or damaged, possibly making the signals more difficult to see.

**Figure 8 - Signal head with partially lit green LED bulb and broken backing plate**

Team members noted that backplates on several of the lights on the overhead mast arms were damaged. It was also observed that many of the auxiliary lights also had damaged backplates, or backplates that were missing entirely. Damaged or missing backplates could lead to signal visibility issues, resulting in motorists inadvertently running red lights and causing angle crashes or motorists not expecting stopped traffic and rear-ending vehicles already stopped at the intersection, such as in crashes 3 and 16 from the crash data.

1. Replace all non-LED traffic signal bulbs with newer LED bulbs to increase signal visibility.
2. Evaluate the existing traffic signal bulbs and replace and/or repair the partially lit LED style bulbs to increase signal visibility.
3. Replace the broken or missing backplates at the necessary signal heads to increase signal visibility. New backplates should include a 3" reflective border in all locations.

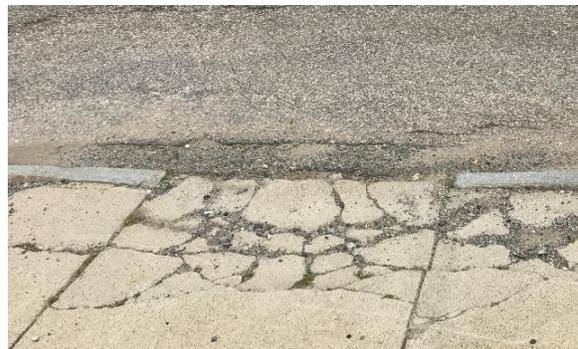
It was noted that there are no crosswalks or pedestrian signals provided across any of the intersection approaches. Team members observed that, despite the lack of crosswalks, there is a continuous sidewalk along the western side of South Washington Street and a sidewalk is provided along the southern side of Draper Avenue. Audit team members also observed that curb ramps were provided on the southwestern and southeastern corners of the intersection, but the ramps were damaged, appeared to have non-ADA compliant grades and landings zones, and were missing tactile warning pads.

**Figure 9 - Broken curb ramp with missing tactile warning pad and no adjoining crosswalk**

1. Consider installing ADA-compliant pedestrian crosswalks, signal heads, and push-buttons to formalize pedestrian crossings.
2. Evaluate the existing curb ramps and repair and/or replace as necessary to meet current ADA guidelines. Additionally, in conjunction with enhancement #1, evaluate the need for and location of future pedestrian ramps to facilitate new crosswalks at the intersection.

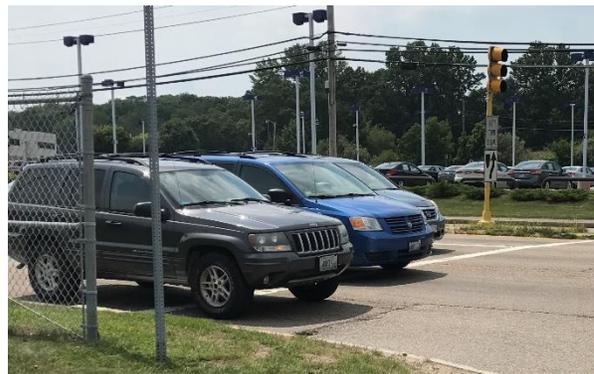
It was noted that pavement markings are extremely faded throughout the intersection. It was observed that on the northbound South Washington Street approach the solid white shoulder line is extremely faded and almost not visible at all, even in bright daylight conditions. Due to the lack of markings, some motorists are now using the northbound shoulder approaching the intersection as a right turn lane. This presents a conflict when a driver from the right travel lane turns without expecting another vehicle to be travelling to their right.

**Figure 10 - Motorists using the faded shoulder as a right-turn lane**

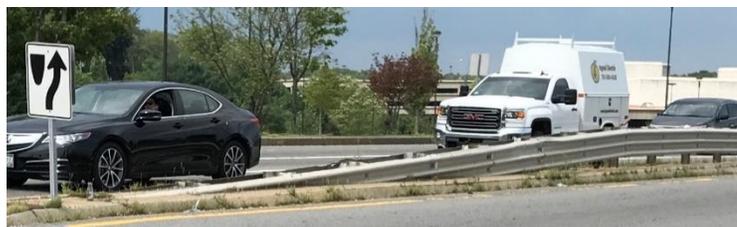
**Figure 11 - South Washington Street southbound approach median, with a buried end and no crash cushion**

Audit team members also noticed that the South Washington Street southbound approach median had a buried end and was missing a crash cushion. This could lead to vehicles ramping up onto the guardrail in the event of a crash.

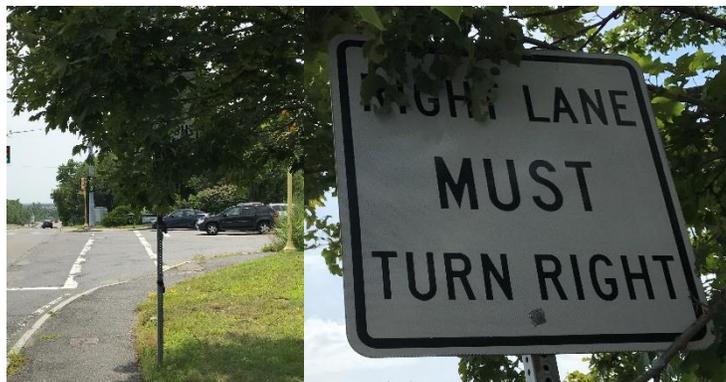
It was also observed that the visibility of some signage for the southbound South Washington Street approach is severely limited. Specifically, audit team members noted that a “RIGHT LANE MUST TURN RIGHT” sign is completely obscured by a tree and unreadable by approaching motorists. Team members also noted that the Allen Avenue street name sign was

**Figure 12 - Southbound lane use sign obscured by tree**

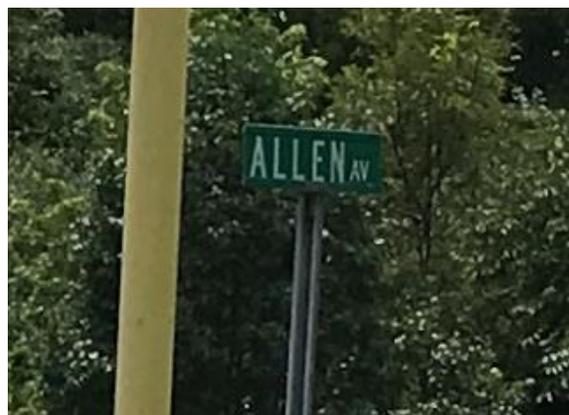
small, placed far away from the intersection, and was set against a backdrop of greenery, making it almost impossible for approaching motorists to see. The obscured signage could cause motorists to be unaware of current lane designations, or unaware of the street they are approaching, leading to weaving and/or sudden slowing/stopping, creating danger roadway conditions.

**Figure 13 - Difficult to see Allen Avenue street sign**

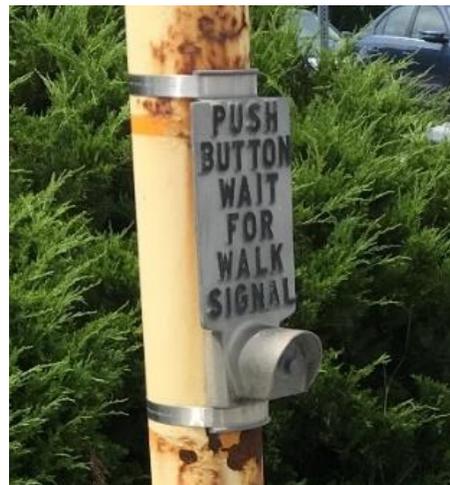
Audit team members noted that pedestrian signal heads and push-buttons were provided for the southern leg crosswalk, but not for the crosswalks on the eastern and western intersection legs. Where provided, the signal heads do not meet current MUTCD guidelines and do not have count-down timers. It was also noted that the pedestrian push-buttons were out-of-date and do not meet current ADA standards. It was also noted that, where provided, the pedestrian curb ramps did not appear to be ADA compliant and did not have tactile warning pads.

**Figure 14 - Non-ADA compliant pedestrian push-button**

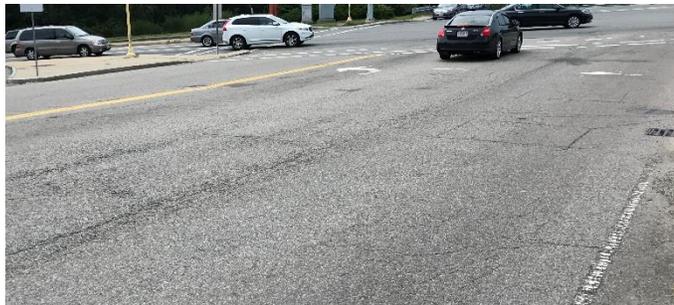
It was observed that pavement markings on all intersection approaches were faded. In the case of the Allen Avenue approaches, team members remarked that the pavement markings were nearly entirely faded and a motorist new to the intersection would likely not know either how many lanes there were in the approach, or what the lane designations would be. This could cause confusion with motorists

**Figure 15 - Missing pavement markings on the westbound Allen Avenue approach**

approaching the intersection unsure of where their lane was, possibly leading to side-swipe, angle, or rear-end crashes. In conjunction with the lack of pavement markings on the intersection approach, it was also noted that a lack of guide lines through the intersection could cause confusion between motorists attempting to make conflicting movements through the large intersection, specifically from the Allen Avenue approaches.

1. Consider restriping and repainting all pavement markings throughout the intersection to increase visibility to motorists.
2. Consider installing advanced warning lane designation markings on all intersection approaches to inform motorists to change lanes as required before approaching the intersection.
3. Consider adding skip-lines to help guide turning motorists through the intersection.
4. Evaluate current pavement conditions and consider filling potholes, ruts, and other irregularities, and sealing all cracks to prevent further pavement deterioration.

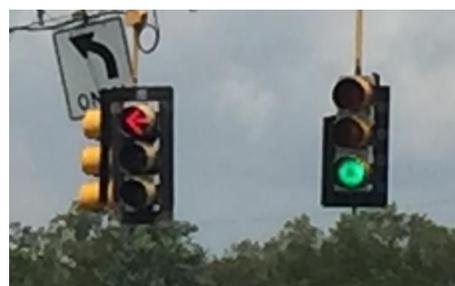
**Figure 16 - Damaged backplates on signal heads**

Audit team members also noted that the signal backplates were also damaged or missing on many of the signal heads.

5. Replace the broken or missing backplates at the necessary signal heads to increase signal visibility. New backplates should include a 3” reflective border in all locations.

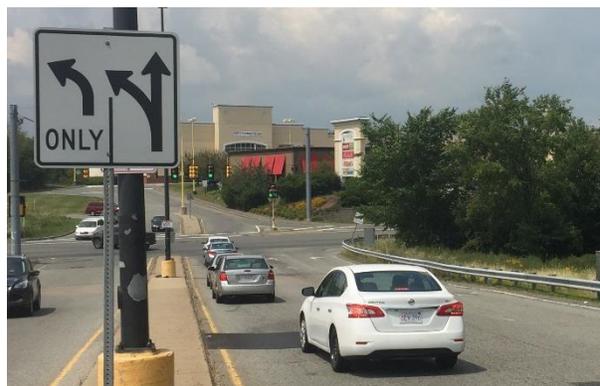
It was noted that there are no advanced warning lane designation signs on South Washington Street for either intersection approach, and no advanced warning sign on the eastbound North Attleboro Market Place Access Road approach. This does not allow motorists to know if they are approaching the intersection in the correct lane for their intended direction of travel. Audit team members also noticed that an incorrect advanced warning lane designation sign was provided on the westbound intersection approach. Where the westbound approach is striped and functions as 3 lanes (exclusive

**Figure 17 - Eastbound North Attleboro Market Place Access Road lane designation signage that does not match pavement markings**

left-turn / left-turn and through / exclusive right-turn), the advances warning sign only shows two lanes (exclusive left-turn / left-turn and through).

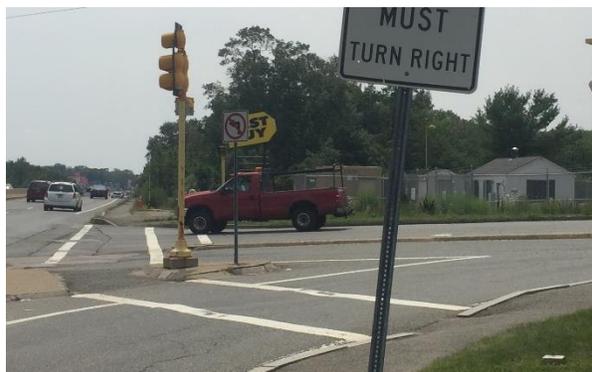
It was first noted that a crosswalk is provided across the western leg of the intersection only. Pedestrian signal heads and push-buttons are only provided across the main trunk of the eastbound approach – there are no signal heads or push-buttons for pedestrians crossing the southbound right-turn slip lane. Where provided, the pedestrian signal heads are not compliant with the latest MUTCD guidelines and do not include count-down timers. Where provided, pedestrian push-buttons are not ADA compliant. Audit team members also noted that the curb ramps did not appear to be ADA compliant and did not have tactile warning pads.

**Figure 18 - Missing pedestrian signal heads across the southbound right-turn slip lane**

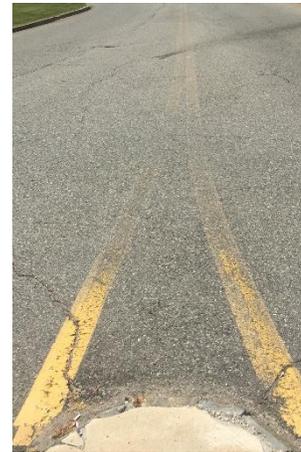
Audit team members noted that pavement throughout the intersection suffered from rutting, pot-holes, and cracking. It was also observed that pavement markings throughout the intersection were faded and/or missing entirely. This is especially true along the eastbound and westbound intersection approaches, and around some of the median and slip lane islands.

**Figure 19 - Faded pavement markings on North Attleboro Market Place Access Road**
