## CHICORA FOUNDATION, INC.

Re: Assessment of the Mann Family Cemetery, North Attleborough, MA

This letter will serve to provide you with my assessment of the Mann Family Cemetery (often called the Draper/Mann Burial Ground) situated in North Attleborough, MA. I had the opportunity to visit the cemetery with you and Ms. Ann Chapdelaine (representing the North Attleborough Historical Commission) on September 24, 2007. During that visit I also viewed the repaired ledger (stored at the North Attleborough Wastewater Treatment Facility), as well as other fragments currently stored with the historical commission.

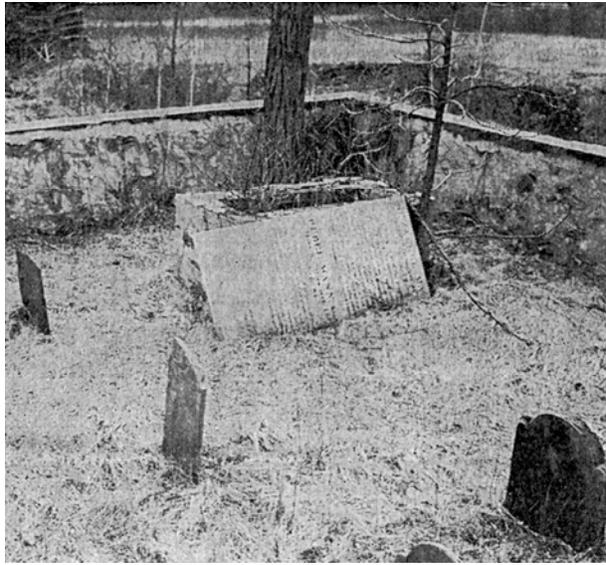
At some time in the past, a rock wall was erected to mark the burial ground and an undated newspaper account explained, “the only way to enter the burying ground is by climbing over the wall.” A photograph (Figure 2) suggests that the wall was in good condition and it appears to have included Portland cement, suggesting a post-1930 date. The photograph reveals that the interior of the walled enclosure was grassed with several scrub trees present. Slate has been used to cap the rock wall. Four headstones and one rock box tomb are shown. The ledger on the box has been slid off, but is otherwise intact. The article lists seven markers in total.

Figure 2. Undated photograph of the cemetery looking toward the south.

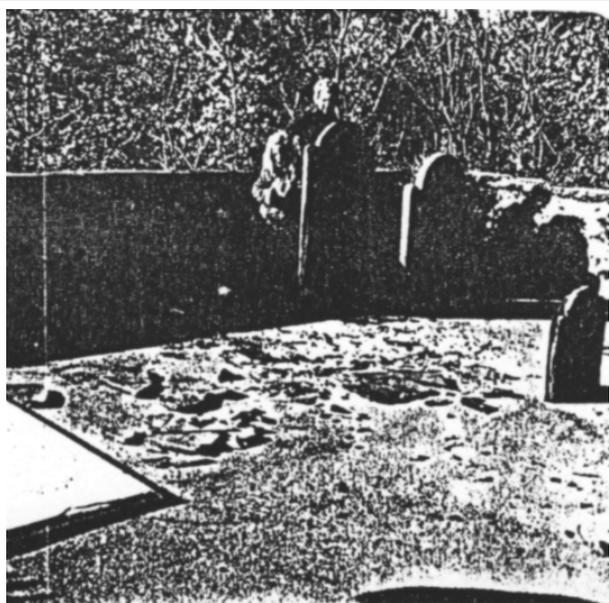
A 1974 account of the cemetery reveals considerable changes during the intervening 23 years (Figure 3). A hole has been cut into the wall to allow a gate (still present today) to be installed. The interior of the graveyard is no longer grassed; instead, a cement pad has been laid. Many of the stones are by this time broken and

lying shattered on the ground, although several appear to still have most of their fragments. The box tomb has been completely removed and the ledger, still seemingly intact, is now laid on the concrete.

The deterioration of the cemetery between 1951 and 1974 is dramatic. Much of the historic fabric has been destroyed and lost. The cemetery today is represented by only a small portion of what was present initially. While the breaks suggest the cause was vandalism, this was exacerbated by placing the stones in hard, unyielding concrete. Once this was done, extensive damage was virtually assured.

Figure 3. The cemetery in 1974 showing extensive damage and loss.

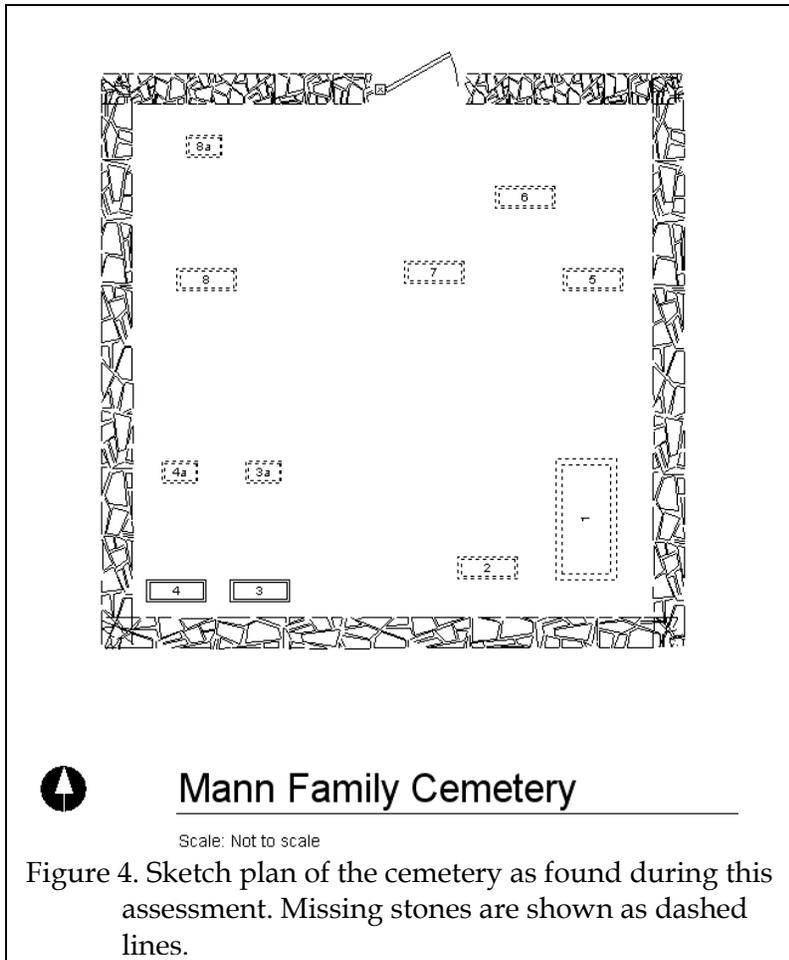
Figure 4. Sketch plan of the cemetery as found during this assessment. Missing stones are shown as dashed lines.

My examination of the cemetery shows evidence of eight marked burials and at least 11 stones (head and foot stones). Today only two of the headstones are still intact and in place (Figure 4). The ledger, now repaired, is still stored at the North Attleborough Waste Water Treatment Plant. Various fragments found during cleaning efforts are stored at the North Attleborough Historical Commission. Most of the stones, however, have disappeared (they are present only as remnants present from the concrete pad extending below grade).

- The concrete pad, identified as 4-inches thick and containing wire mesh reinforcement, should be removed as soon as practical. This will

require a two-step process with the crew exercising the greatest possible caution. The first step will be to cut around the embedded stones using hand-held diamond blade concrete saws. The cut lines should be as close to the stone as practical, but care should be taken to avoid any further damage. After the stones are no longer integral to the slab, paving breakers can be used to demolish the concrete. Afterwards the concrete can be removed by hand, along with the wire mesh.

- Concrete on the individual stones will need to be removed by a stone conservator. Afterwards the remnants can be reset in pea gravel.
- Lawn markers, set flush to the ground, can be installed to provide the inscriptions for the stones missing. This will allow the remnant stones to remain the dominant 3-dimensional focus of the cemetery, but will provide the visiting public with the missing inscriptions. The markers will be clearly modern, avoiding confusion on the part of the public.

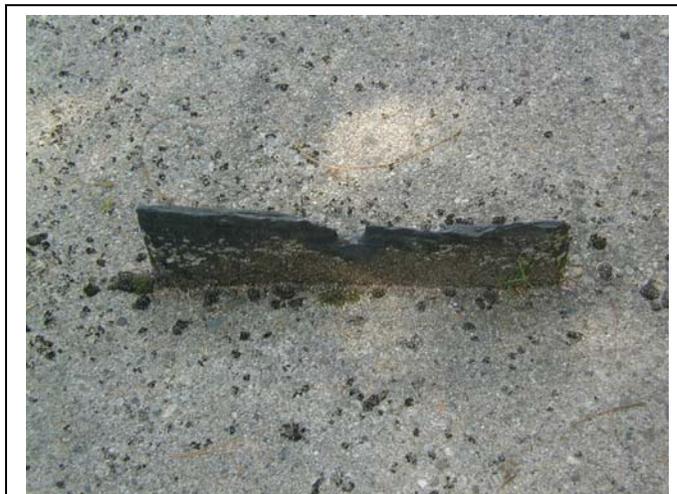
As discussed above, the majority of the monuments in the cemetery have been extensively damaged and little remains except for the below grade bases (Figure 5). Repair of these stones is not feasible – not only is the bulk of the stone missing, but the fragments remaining are so small that cohesive repair would be very difficult and costly. The fragments remaining, however, should be cleaned of adhering cement and left in place to mark the locations of the original monuments. New lawn markers, placed flush to the ground, can be used to provide the original inscriptions. We do not encourage attempts to replicate the original markers since there is not adequate information. Any reproductions would be artistic creations and not historically accurate reproductions.

Figure 5. Example of a badly fragmented stone at the Mann Family Cemetery.

- All broken monuments at the cemetery should be excavated and the adhering OPC removed mechanically by a stone conservator. These monuments should be reset using pea gravel.
- Graves with damaged slate markers should be marked using flush lawn markers that do not detract from the landscape of the cemetery, but allow complete inscriptions to be presented to the public.

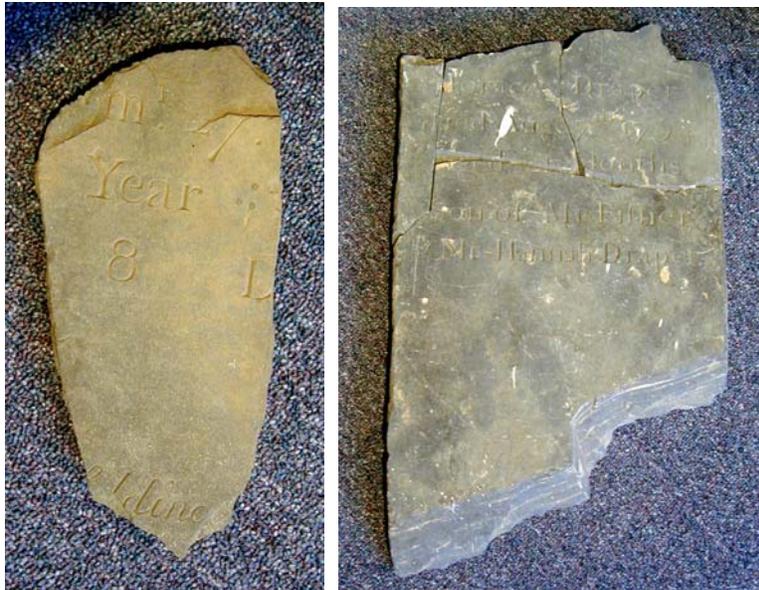
Figure 6. Two of the larger fragments held by the Historical Commission.

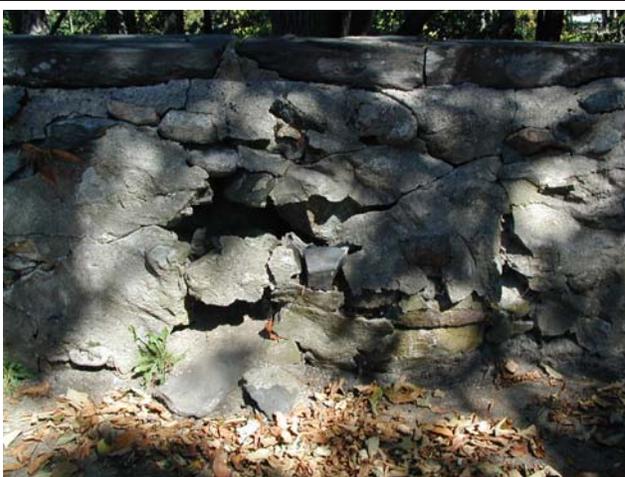
The only other feature identified at the cemetery is the rock wall. A section of the wall is seen in Figure 7, where it is clear that there are numerous defects. There are several lengths that are significantly out of plumb, several wall areas where rocks

are missing, and an area of displaced coping.

As previously mentioned, the presence of ordinary Portland cement (OPC) in the wall suggests that it (or its repair) post-dates 1930. Moreover, the construction, using large amounts of spoil, rubble, and even brick, is inconsistent with traditional dry laid walling techniques. A

Figure 7. Example of wall failure. Note cracking and loss.

In contrast, the present wall is better described as a rubble wall. Such walls often had a core of debris that allowed water drainage and helped prevent freeze-thaw damage that

Repair of the wall as it stands will be quite expensive since the damage is sufficiently extensive as to require essentially the entire wall be rebuilt. Historic Scotland recommends that such rebuilding utilize a painted grid coupled with photography to allow the wall to be disassembled and rebuilt into its original position (see <http://www.historic-scotland.gov.uk/informrubble.pdf>). This will be a quite expensive undertaking. Therefore, a reasonable first question involves the historical significance of this wall – is it part of the historic fabric of the cemetery? If so, it is appropriate, in spite of the cost, to repair (i.e., rebuild) the wall. If the wall is not historically significant, then replacement would be a more economic solution.

If the wall is to be replaced, then it should be replaced with materials that are in keeping with the historic context of the property. A chain link fence would be out of place and detract from the character of the cemetery. I strongly recommend the use of dry stone construction – it is historically appropriate and is designed for the harsh environmental conditions of North Attleborough.

- An initial decision must be made regarding the historic significance of the existing wall. Repair is possible, but will be costly. Replacement is likely a more appropriate option and I recommend the replacement wall be dry laid. This technique is historically appropriate and would blend with the cemetery setting and context.

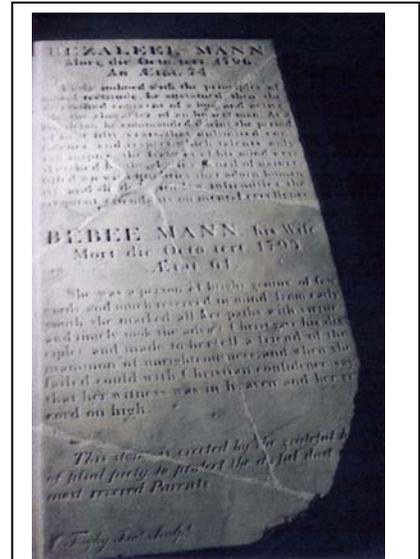
Figure 8. Bezaleel & Bebee Mann stone, after treatment
