TOWN OF NORTH ATTLEBOROUGH, MASSACHUSETTS
 DEPARTMENT OF PUBLIC WORKS

WATER MAIN TRENCH DETAIL
 N.T.S.

Detail Number:
 W-4.1

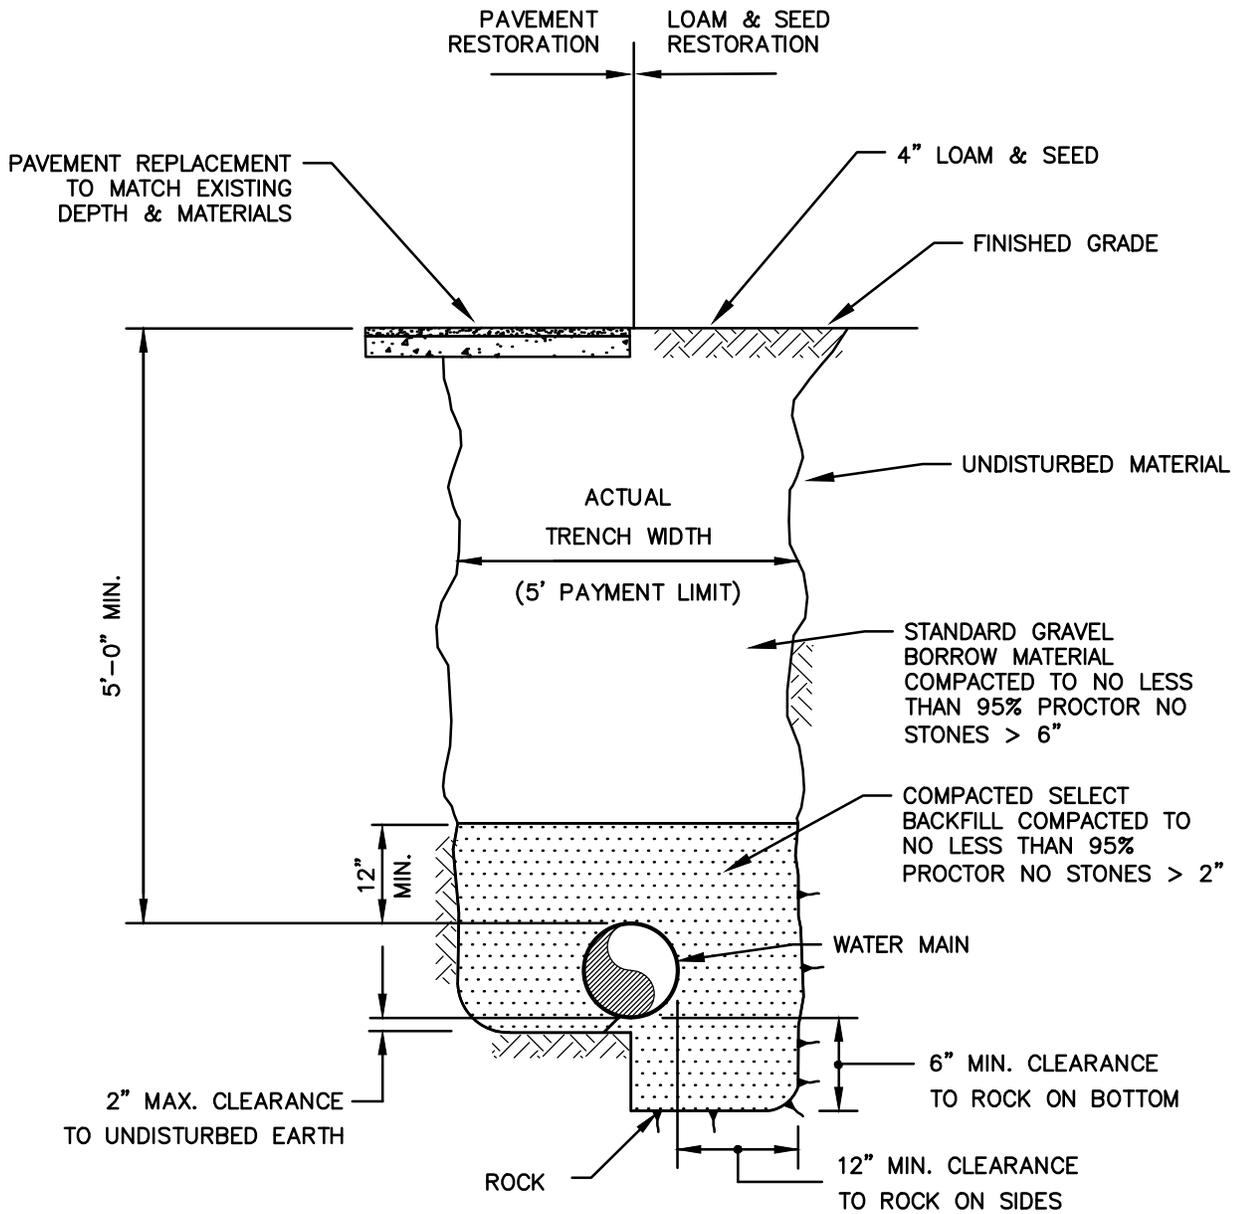
NOTE:
 SUITABLE BACKFILL SHALL BE SELECTED FROM EXCAVATED MATERIALS AND IS SUBJECT TO THE APPROVAL OF THE NADPW. FRACTURED ROCK OR HAMMERED/BROKEN LEDGE SHALL NOT BE USED FOR BACKFILL.
